# The White Horse Trail

Parish of Broad Town section  
Condition report  
Broad Town PC Footpath Working Group

Issue 1 December 2018

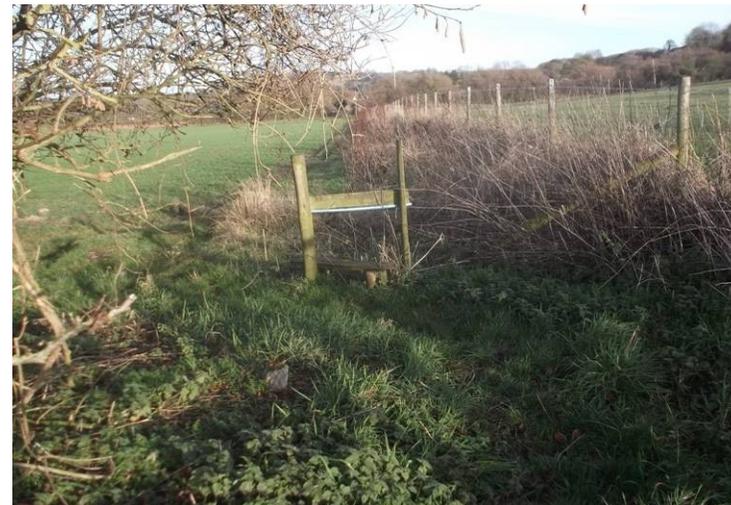
2. Looking towards BT. This stile is now standing in isolation it's only current use is to provide a post for way marking – could be removed

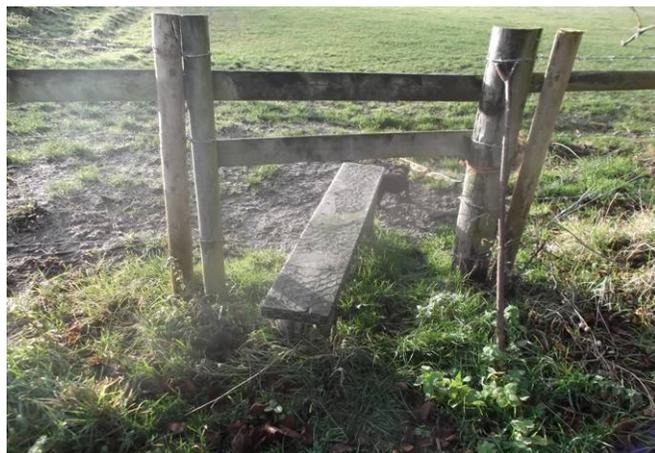
last 'necessary' stile on the Clyffe Pypard side of the boundary. Good condition - requires way marking for anti-clockwise' walkers

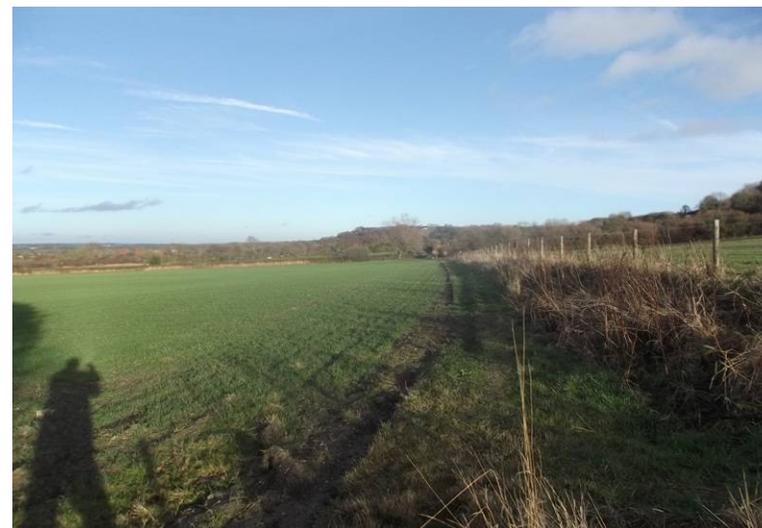
3. Looking toward BT. Path in generally good order.

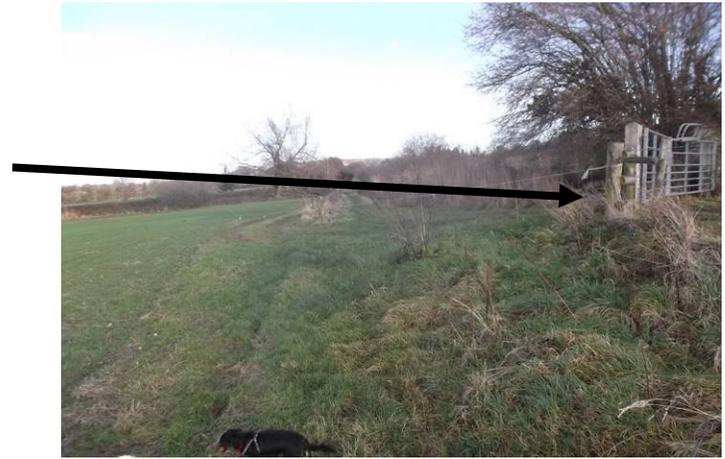
5. Looking toward BT. It can't be seen in the picture but a single electric wire stretches across from gate on the right.

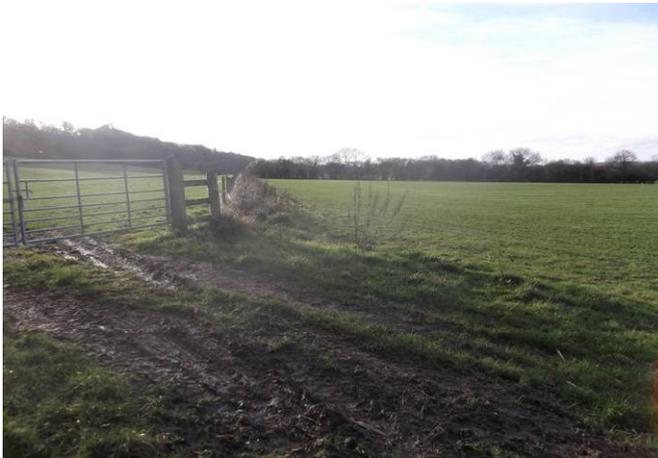
4. Looking toward CP. This is the theoretical CP/BT parish boundary SU084773. The path is clear here but a single electric fence wire is stretched across the path. It might be better to provide a new stile close to the fence line.

1. Establish who the various land owners are and engage with them
2. At 4. New stile
3. At 6. New stile
4. At 8. Possible stile required?
5. At 17. Gate post repair
6. At 20. Path clearance
7. At 24. Path improvement – steps?
8. At 27 Gate padlocked at SU098781
9. At 29/30 Path tidying
10. At 32 Path tidying
11. At 33 Path clearance and tidying at landslip
12. At 36/36 Major clearance, path reconstruction or path realignment
13. At 37 Fallen tree clearance
14. At 38 Gate readjustment
15. At 40 Path repair and clearance
16. At 47 New stile?
17. At 52 Stile repair
18. At 57 Stile repair
19. Way marking will need revising and replacement in places through out the BT section of the WHT.

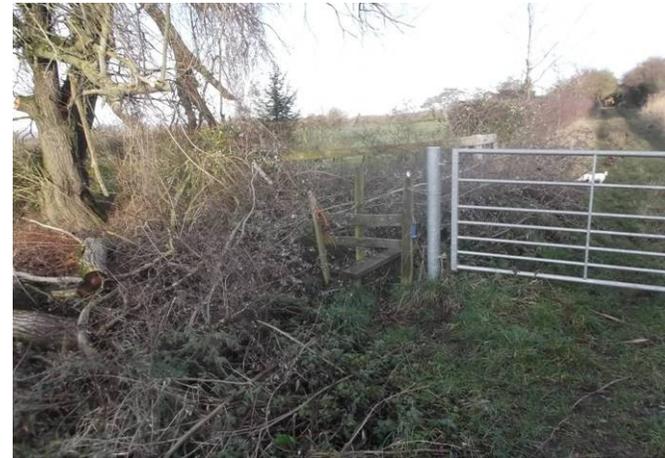
6. Looking east toward BT. This stile Requires new posts. Requires way marking

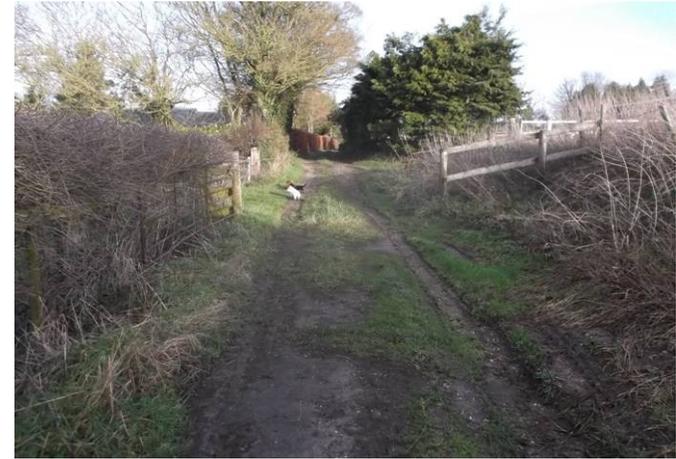
8. Looking east. This gate is generally open, but there is no provision for access if gate shut or locked. Does it need a stile?

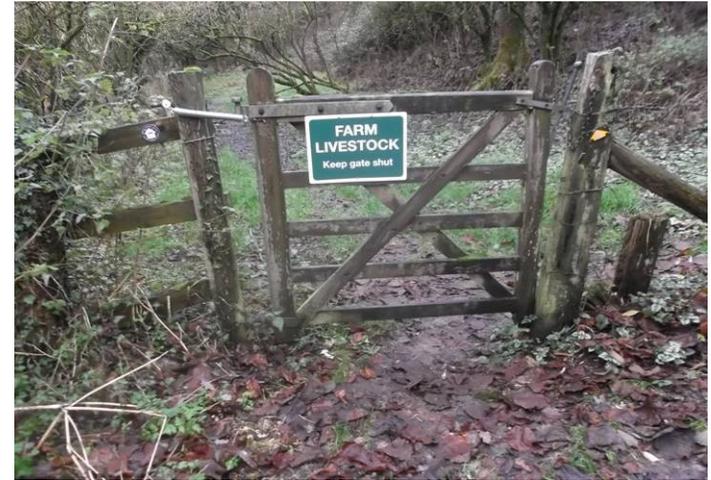
17. Looking east uphill. RH gatepost requires replacing or straightening.

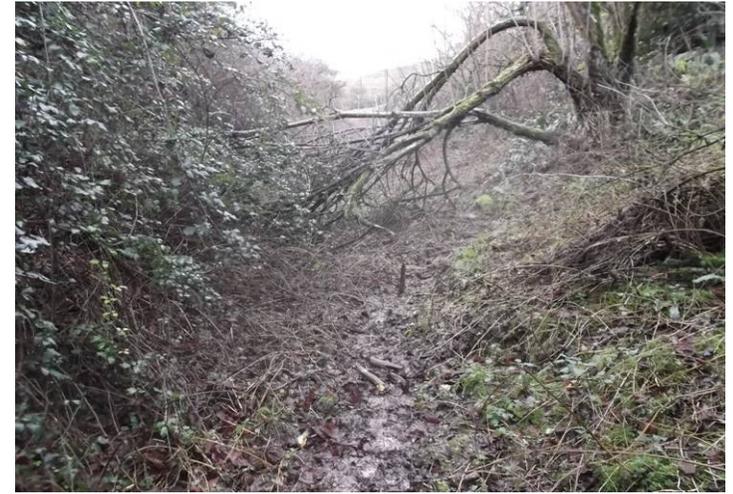
20. Looking east uphill just beyond the point where BTOW32 crosses over. From here to the top of the path, light clearance is required.

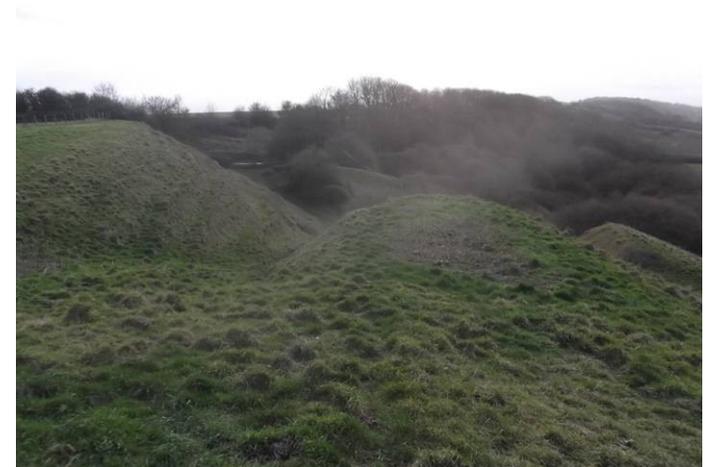
24. Looking back down (west) the correct path that runs along the top of the ridge. Some path improvement could be of use at this location.

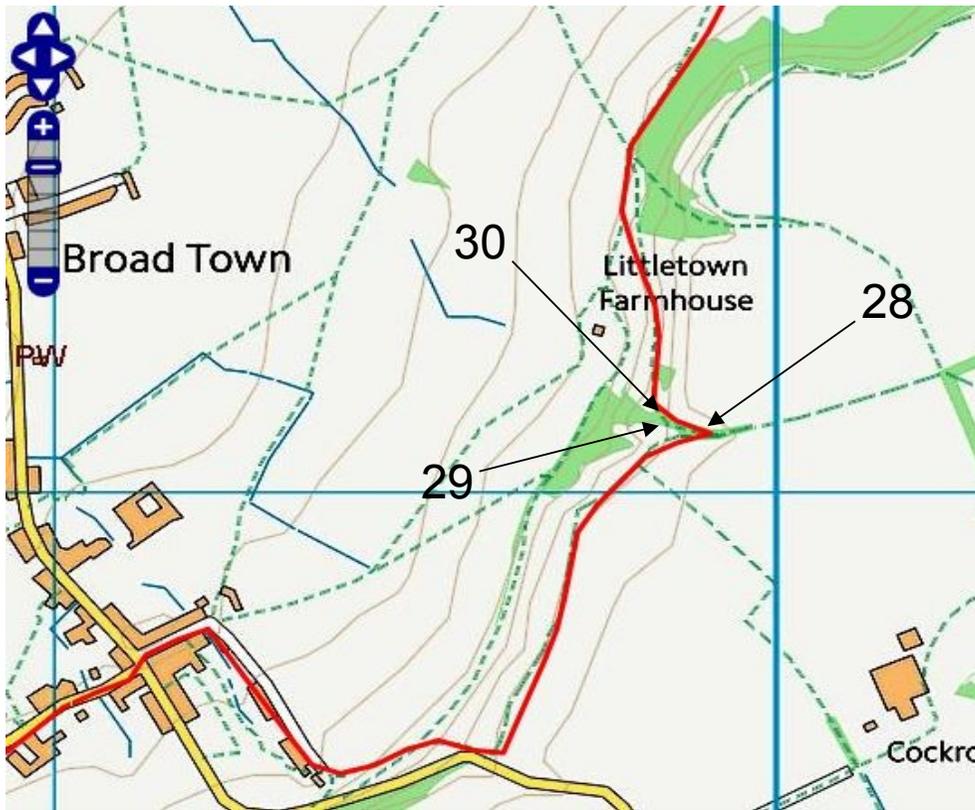
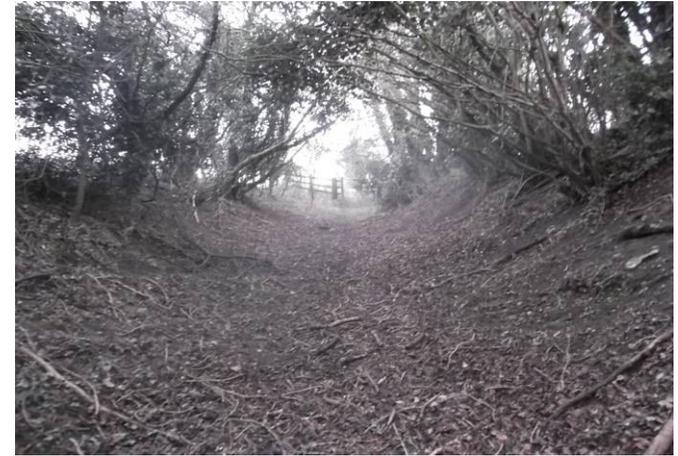
29. & 30. The view up and down the gully path some light clearance and path tidying required

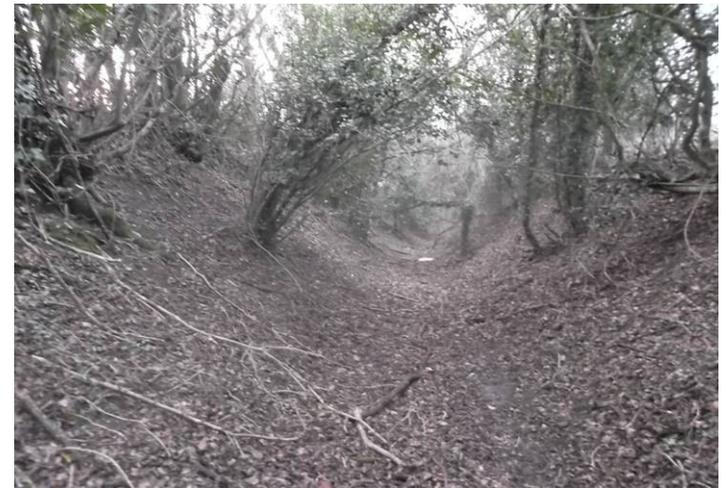
28. The gate at the top of the gully and the beginning of BTOW35. No way marking for the WHT.

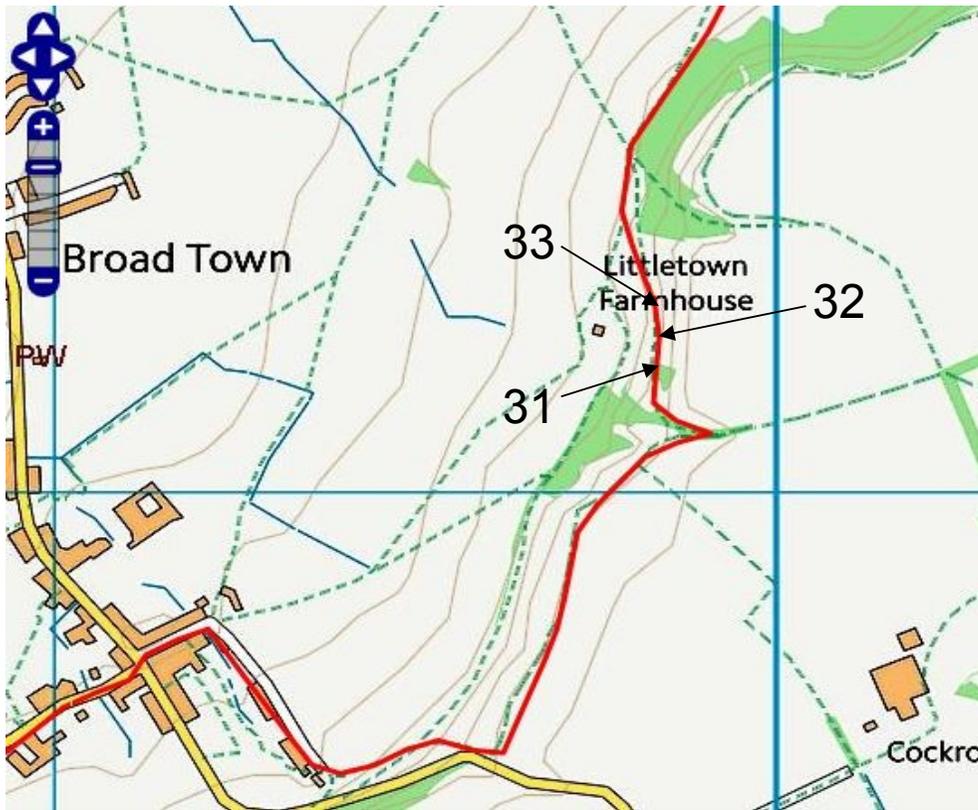
32. Path requires general light clearance and tidying.

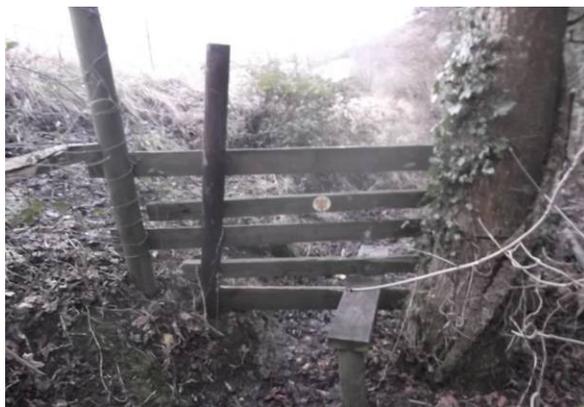
31. Stile in solid condition but requires WHT way markers.

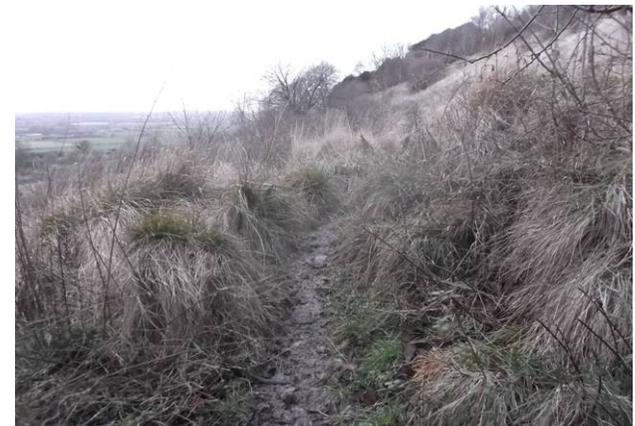
33. Path tidying/clearance required over landslip site

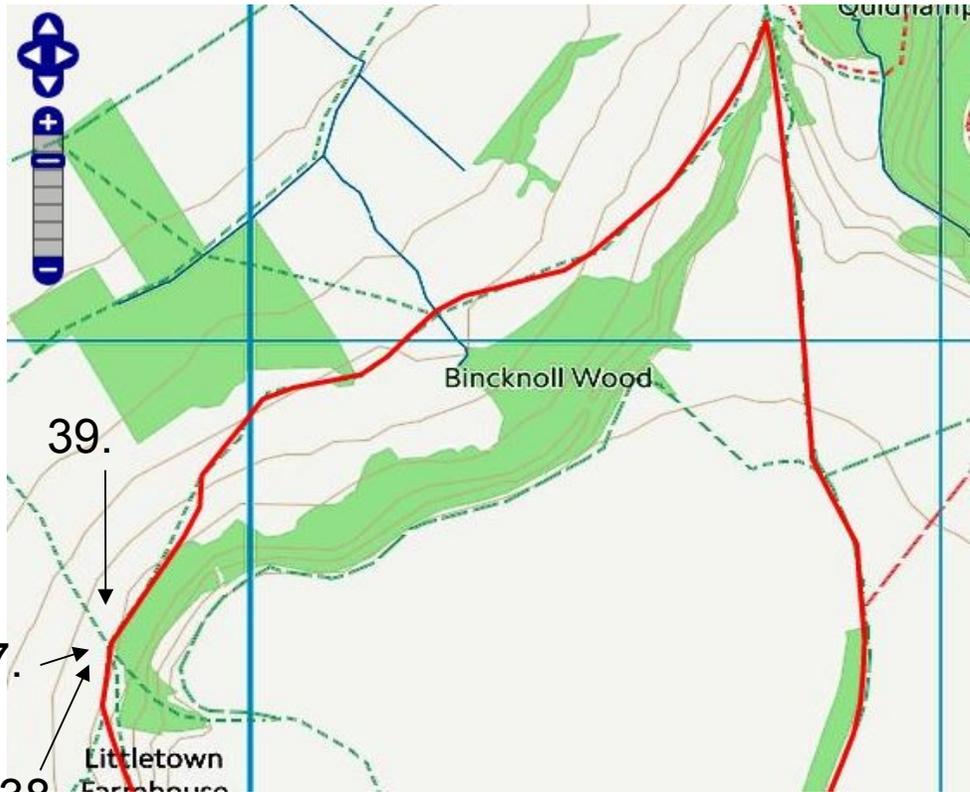
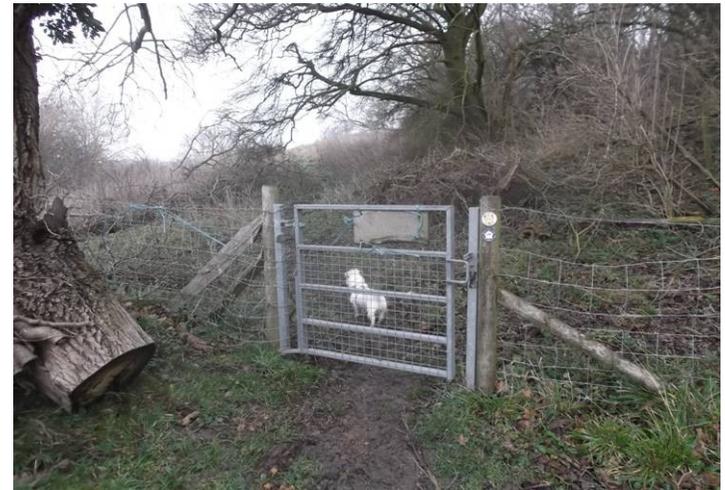
38. & 39. Gate requires adjusting –won't shut – and way marking clarifying.

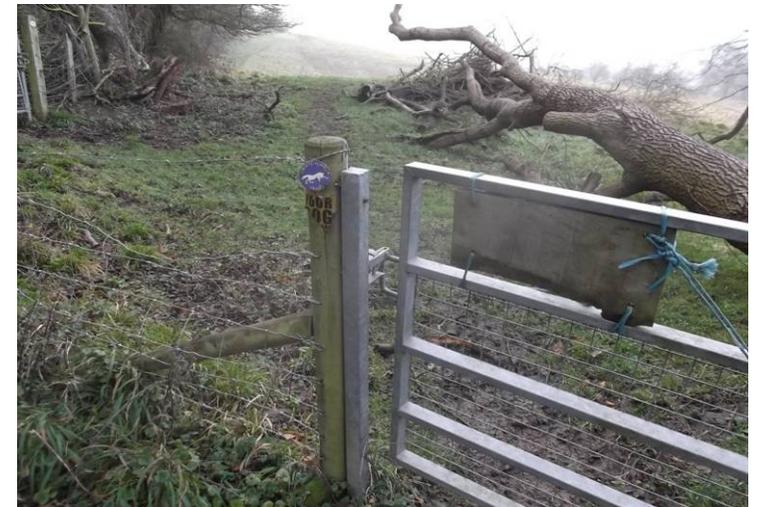
37. This tree has fallen in the last 8 months and requires clearing as although it is not directly affecting the WHT it is blocking BTOW35.

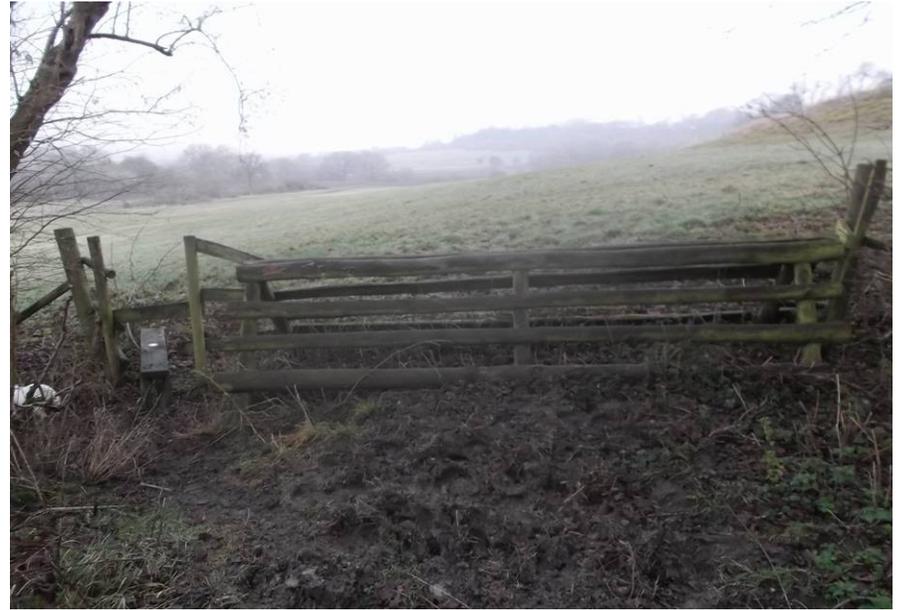
41. & 42. Stile is combined with a horse jump suggesting horses have land owner permission. Stile is ok but maybe improve way marking.

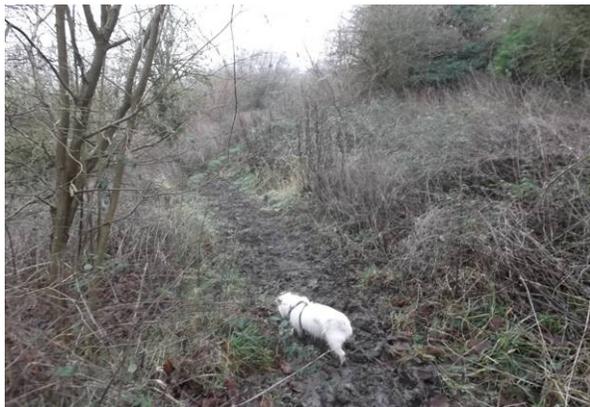
40. Path requires undergrowth clearance and tidying or modifying ground conditions. Path has been used by horses and badly poached, even though it isn't a bridle way – maybe with land owner permission.

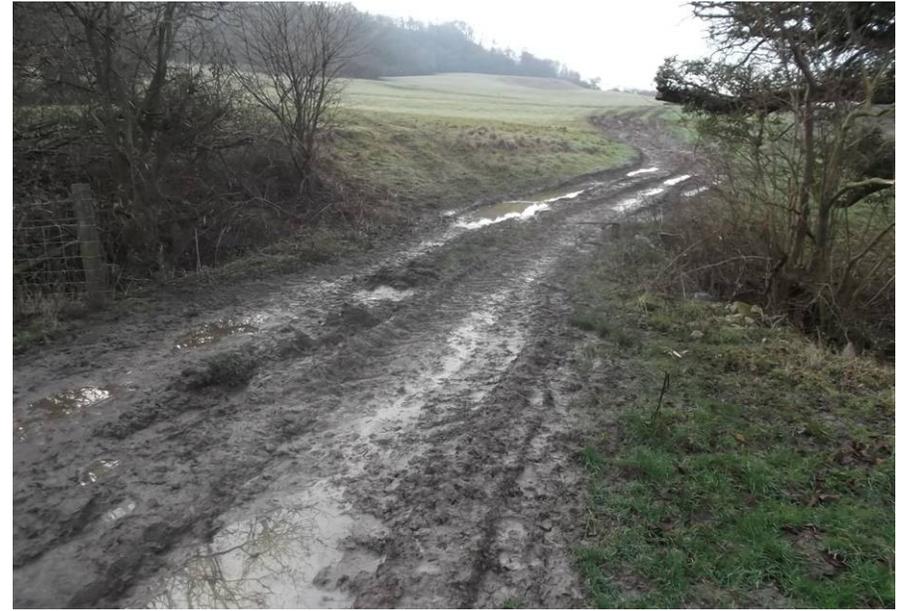
47. & 48. Heavily rutted track – gates stiles and fences missing – maybe a stile will be required

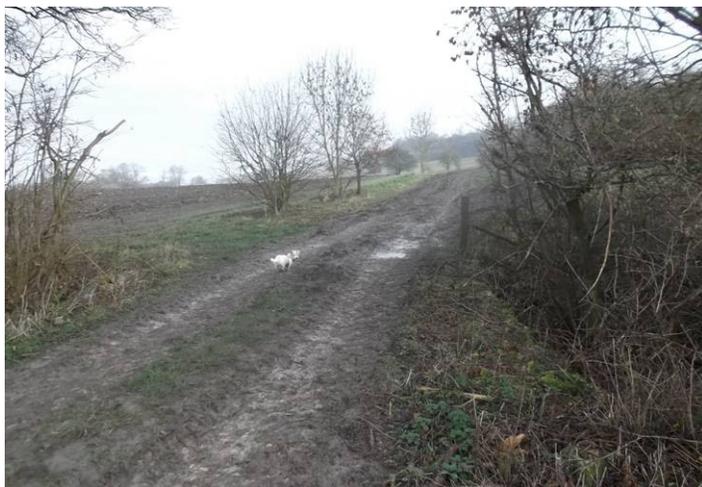
46. This area has seen a lot of woodland clearance of late and the path/track is heavily rutted, will probably improve in time. Requires way marking and maybe a stile adding when fences and gates are replaced. Way marking to BTOW36 is missing

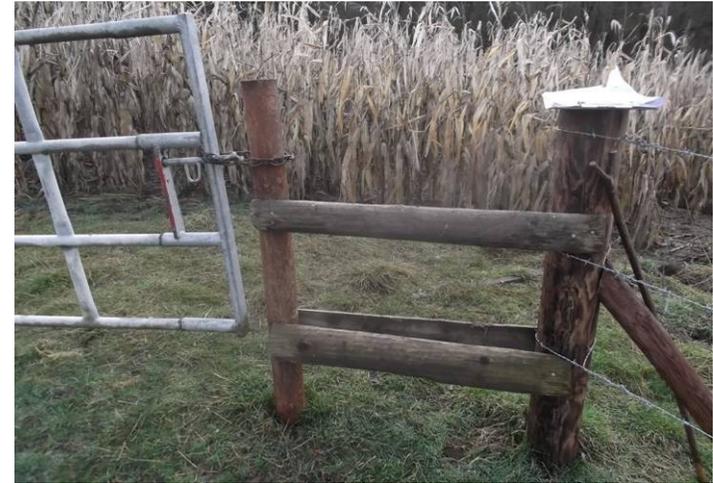
52. & 53. On the other side of the maze belt, this stile and gate have been installed but the stile is not complete – needs a step. Also needs way marking.

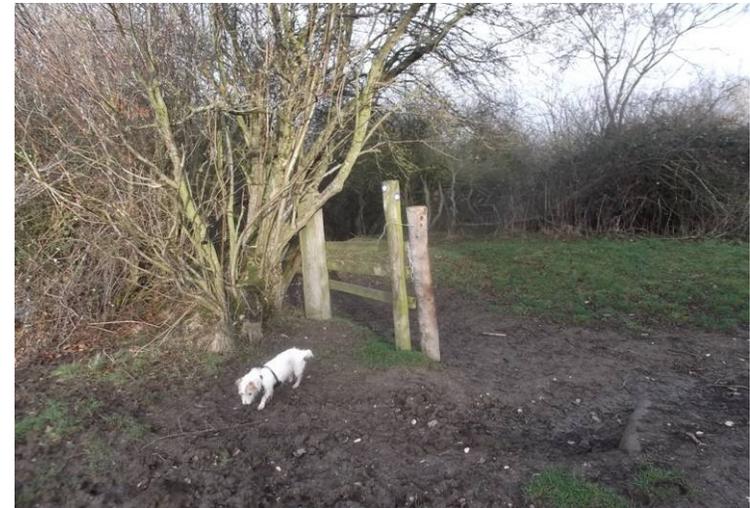
57. The point where BTOW30 meets BTOW40 & 41 at the track leading Bincknoll Castle. Stile requires replacing and tidying way marking.

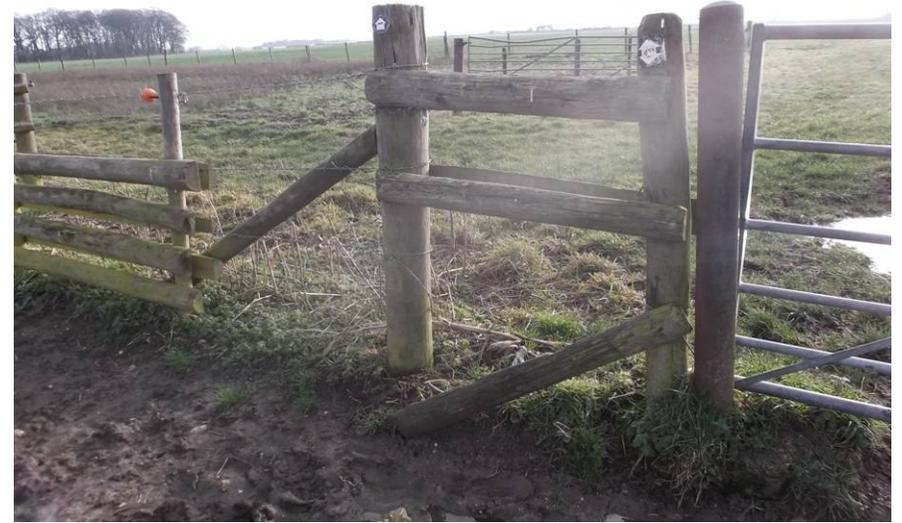
59. The first Broad Hinton Stile on BHIN10 requires repair and the gate is padlocked shut
